Manhole Inspection Summary

Manhole # S49K__023MH

Insp Date: **3/3/09 10:03 AM**

Location Address: **2434 fait ave**

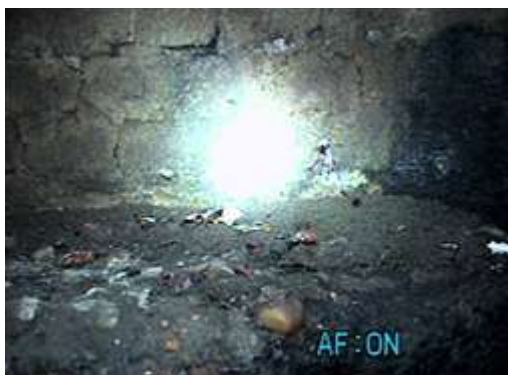
Misc.

bench debris

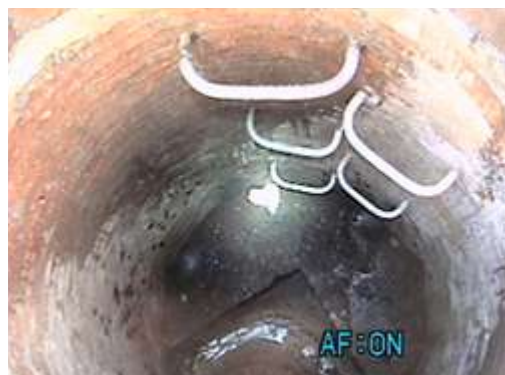
Defect 4

Steps Count: **5** Missing: **0** ☒ **Corroded**

cor. steps

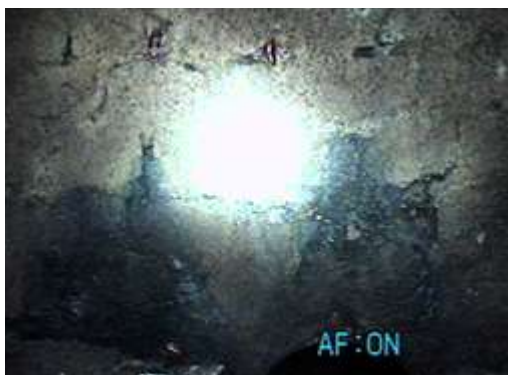
Defect 3

Infiltration: ☐ None ☐ Joint ☐ Cracks ☐ Mortar ☐ Roots ☒ **Wall**

barrel wall infiltration

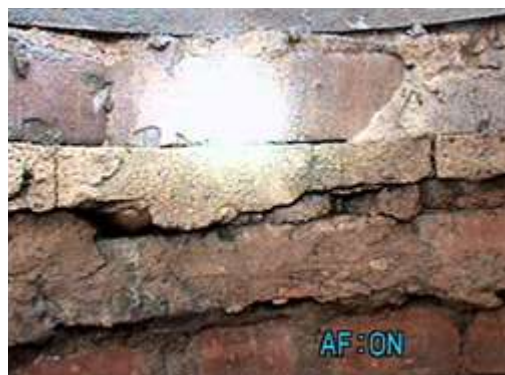
Defect 1

Condition: ☐ Sound ☒ **Cracked** ☐ Root Intrusion ☒ **Loose Brick** ☒ **Deteriorated**

frame adj cracked, loose bricks, deteriorated

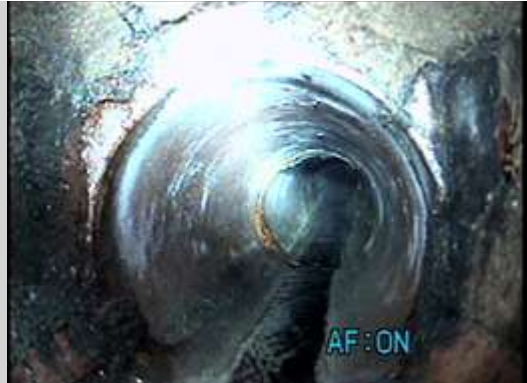
12 O'Clock Outflow

8 in. Circular Gravity Sewer
Pipe Out @ 12 O'Clock

Invert Depth: **9.50** (ft.) Flow Characteristics: **Fast**

Infiltration: **None** Pipe Seal Cond: **Unknown**

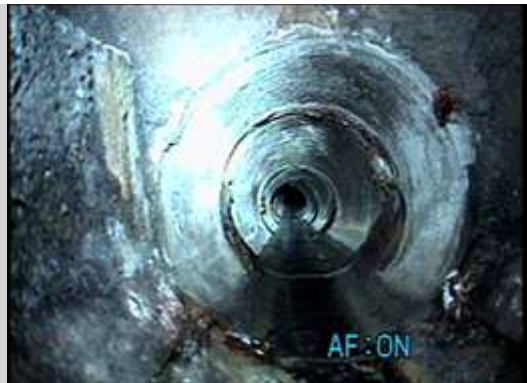
3 O'Clock Inflow

8 in. Circular Gravity Sewer
Pipe In @ 3 O'Clock

Invert Depth: **9.33** (ft.) Flow Characteristics: **Fast**

Infiltration: **None** Pipe Seal Cond: **Unknown**
